Master Drainage Plan
for the
Town of Bayfield
Bayfield, Colorado

September 2014

Souder, Miller & Associates
112 West Montezuma Avenue, Suite 2
Cortez, Colorado 81321
970-565-4465

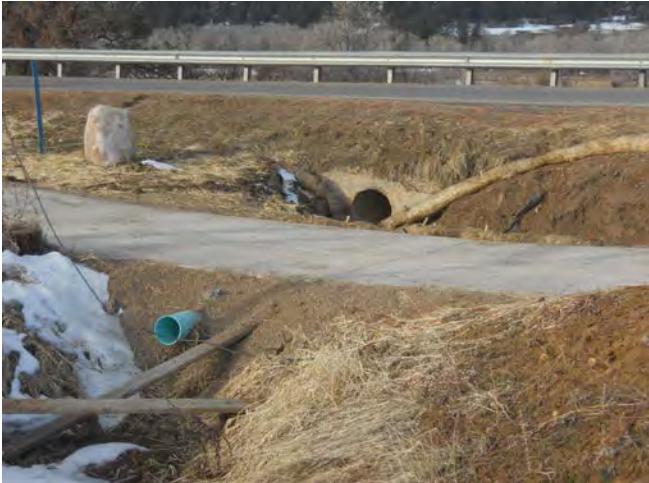
Photo 9 – Pond 1 – Outlet Pipe Near Top of Pond Rim – Debris in Front of Outlet Pipe

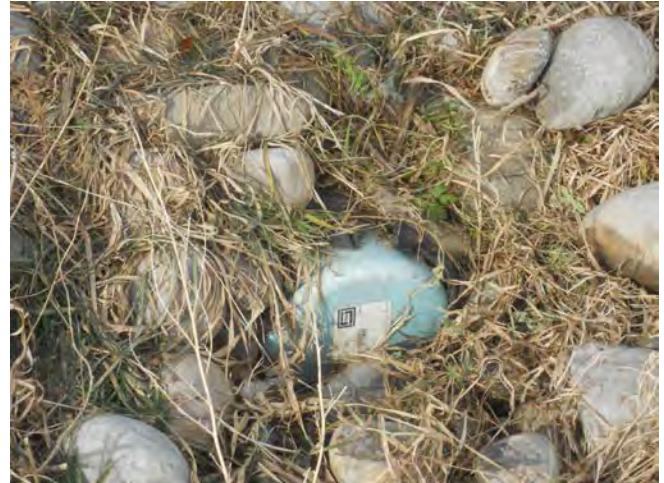
Photo 12 – Pond 6 – Outlet Pipe Obstructed

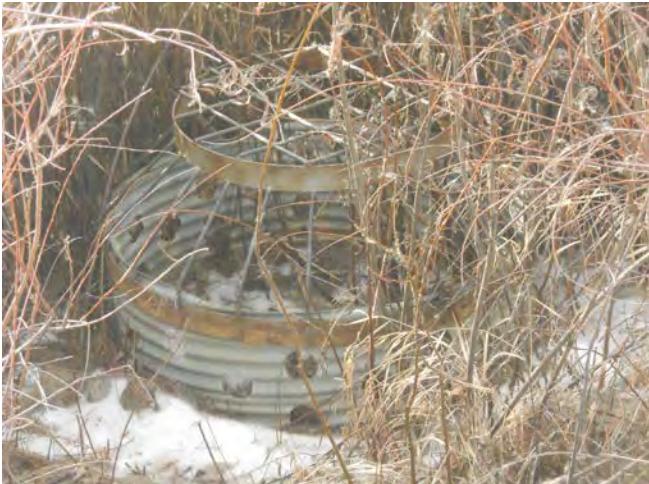
Photo 10 – Pond 2 – Outlet Structure, Vegetation Obstructing Flow to Structure

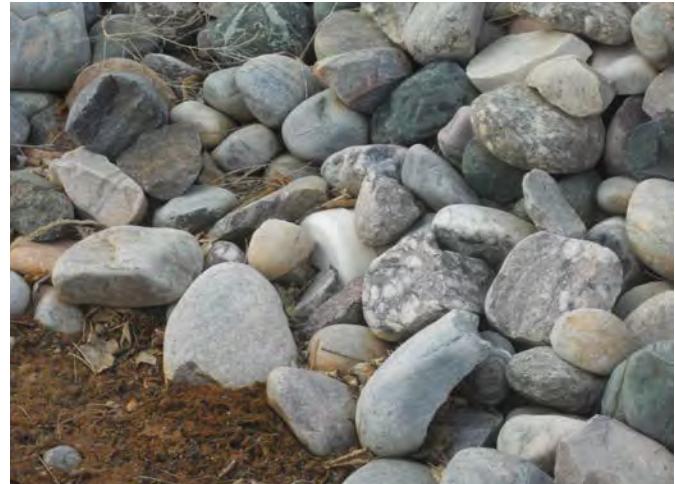
Photo 13 – Pond 7 - Outlet Pipe Obstructed

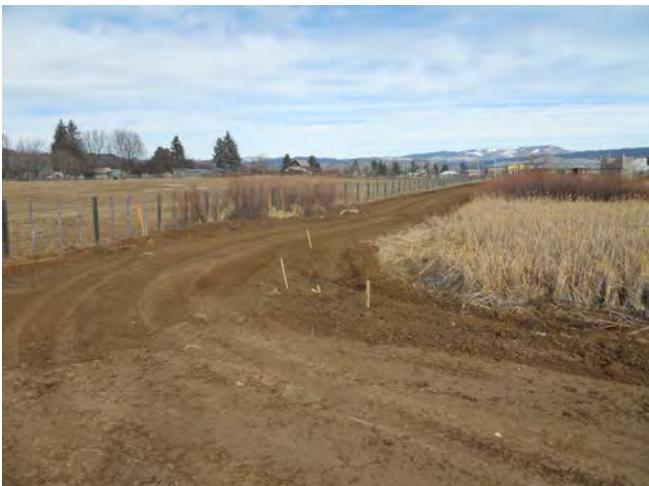
Photo 11 – Pond 3 – Cattails and other Vegetation on Ponding Area

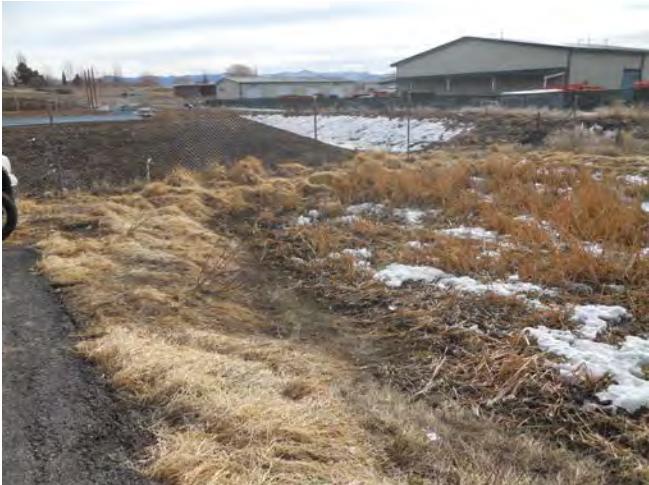
Photo 15 – Pond 9 –Heavily Silted with Significant Vegetation Growth, Outlet Pipe Located Approximately Near Center of Pond, Overgrown

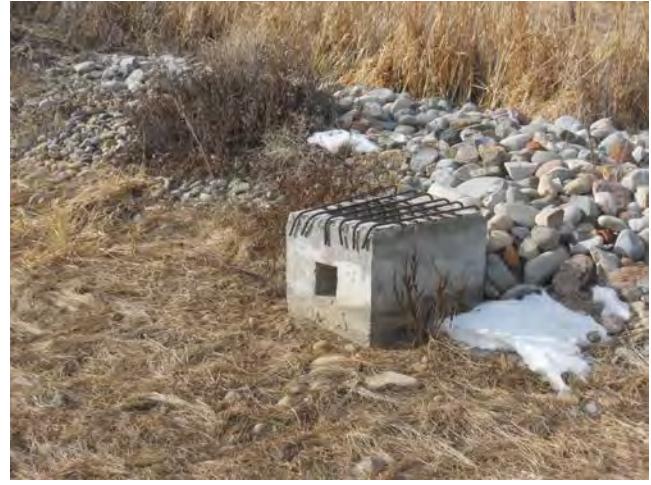
Photo 18 – Pond 11 – Outlet Structure, Containment Berm is at Approximately Same Elevation as Top of Outlet Structure

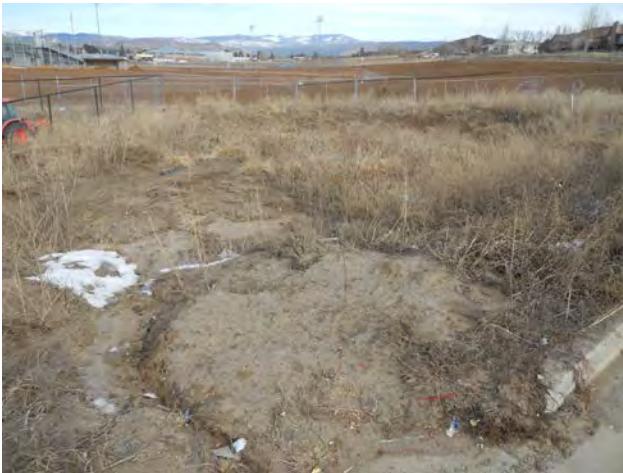
Photo 16 – Pond 10 - Heavily Silted with Significant Vegetation Growth, Outlet Pipe Silted Over/Not Visible

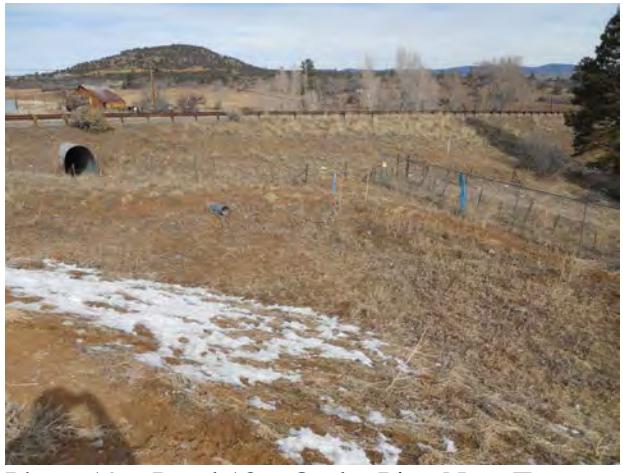
Photo 19 – Pond 18 – Outlet Pipe Near Top of Containment Berm and Appears to be Heavily Silted

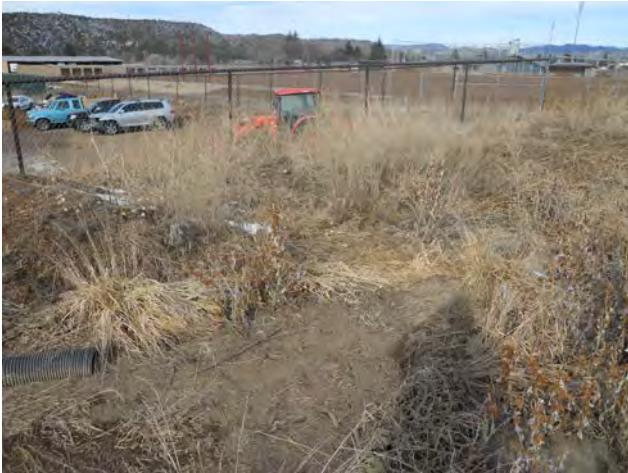
Photo 17 – Pond 10 - Heavily Silted with Significant Vegetation Growth, Outlet Pipe Silted Over/Not Visible, Pond Spills Over Into Adjacent Property

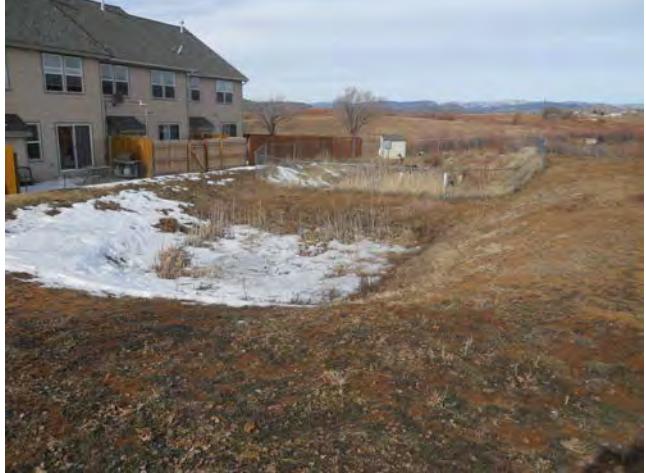
Photo 20 – Pond 21 – Pond is Heavily Silted, Outlet pipe Not Visible, Significant Vegetative Growth

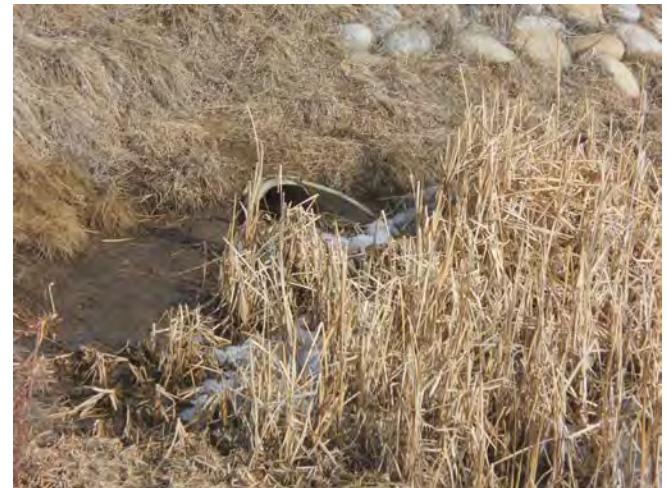
Photo 24 – Pond 25 – Pond Outlet Pipe
Silted, Pond is Silted w/Heavy Vegetative Growth

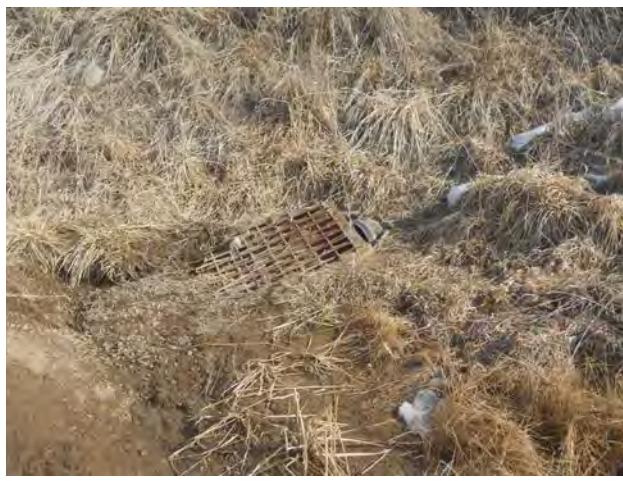
Photo 23 – Pond 25 – Inlet Pipe Obstructed

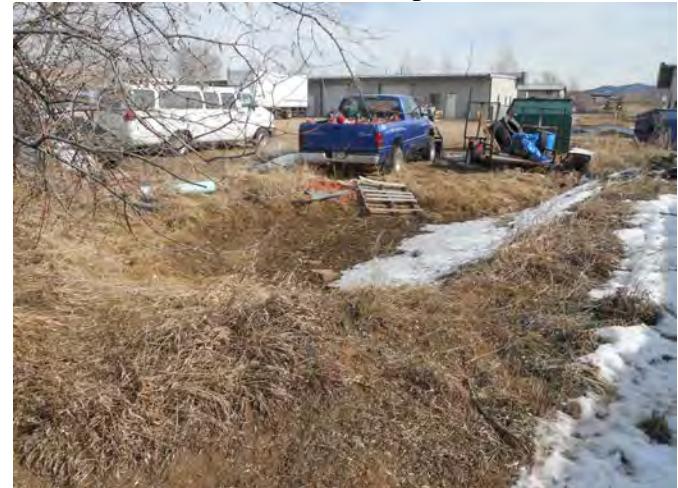
Photo 26 – Pond 26 – Heavily Silted, Debris
and Vegetation in Pond

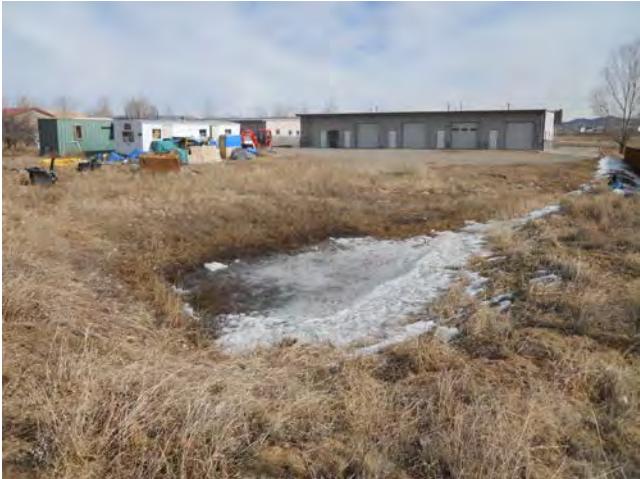
Photo 27 – Pond 27 – Heavily Silted
w/Vegetative Growth

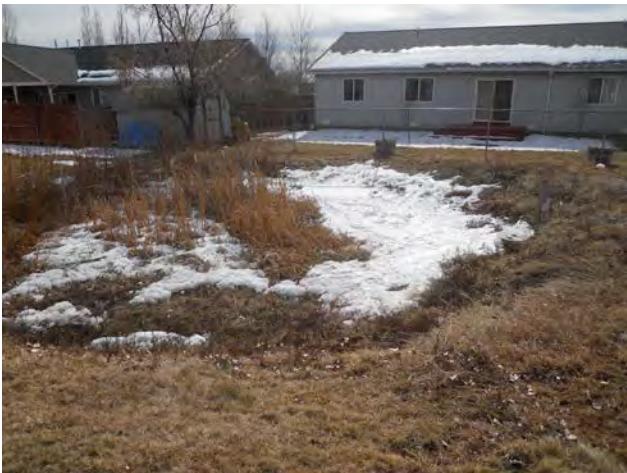
Photo 28 – Pond 28 - Heavily Silted
w/Vegetative Growth

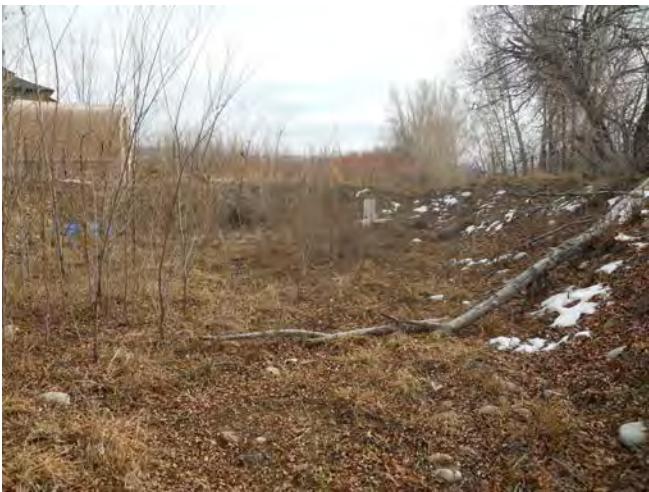
Photo 29 – Pond 34 – Vegetative Growth,
Including trees and Debris
