Memo

From: Sara Brandenburg and Sean Moore (SME Environmental, Inc.)

Date: February 26, 2024

Re: Mapping of Aquatic Resources on the future Bayfield Tractor Supply property

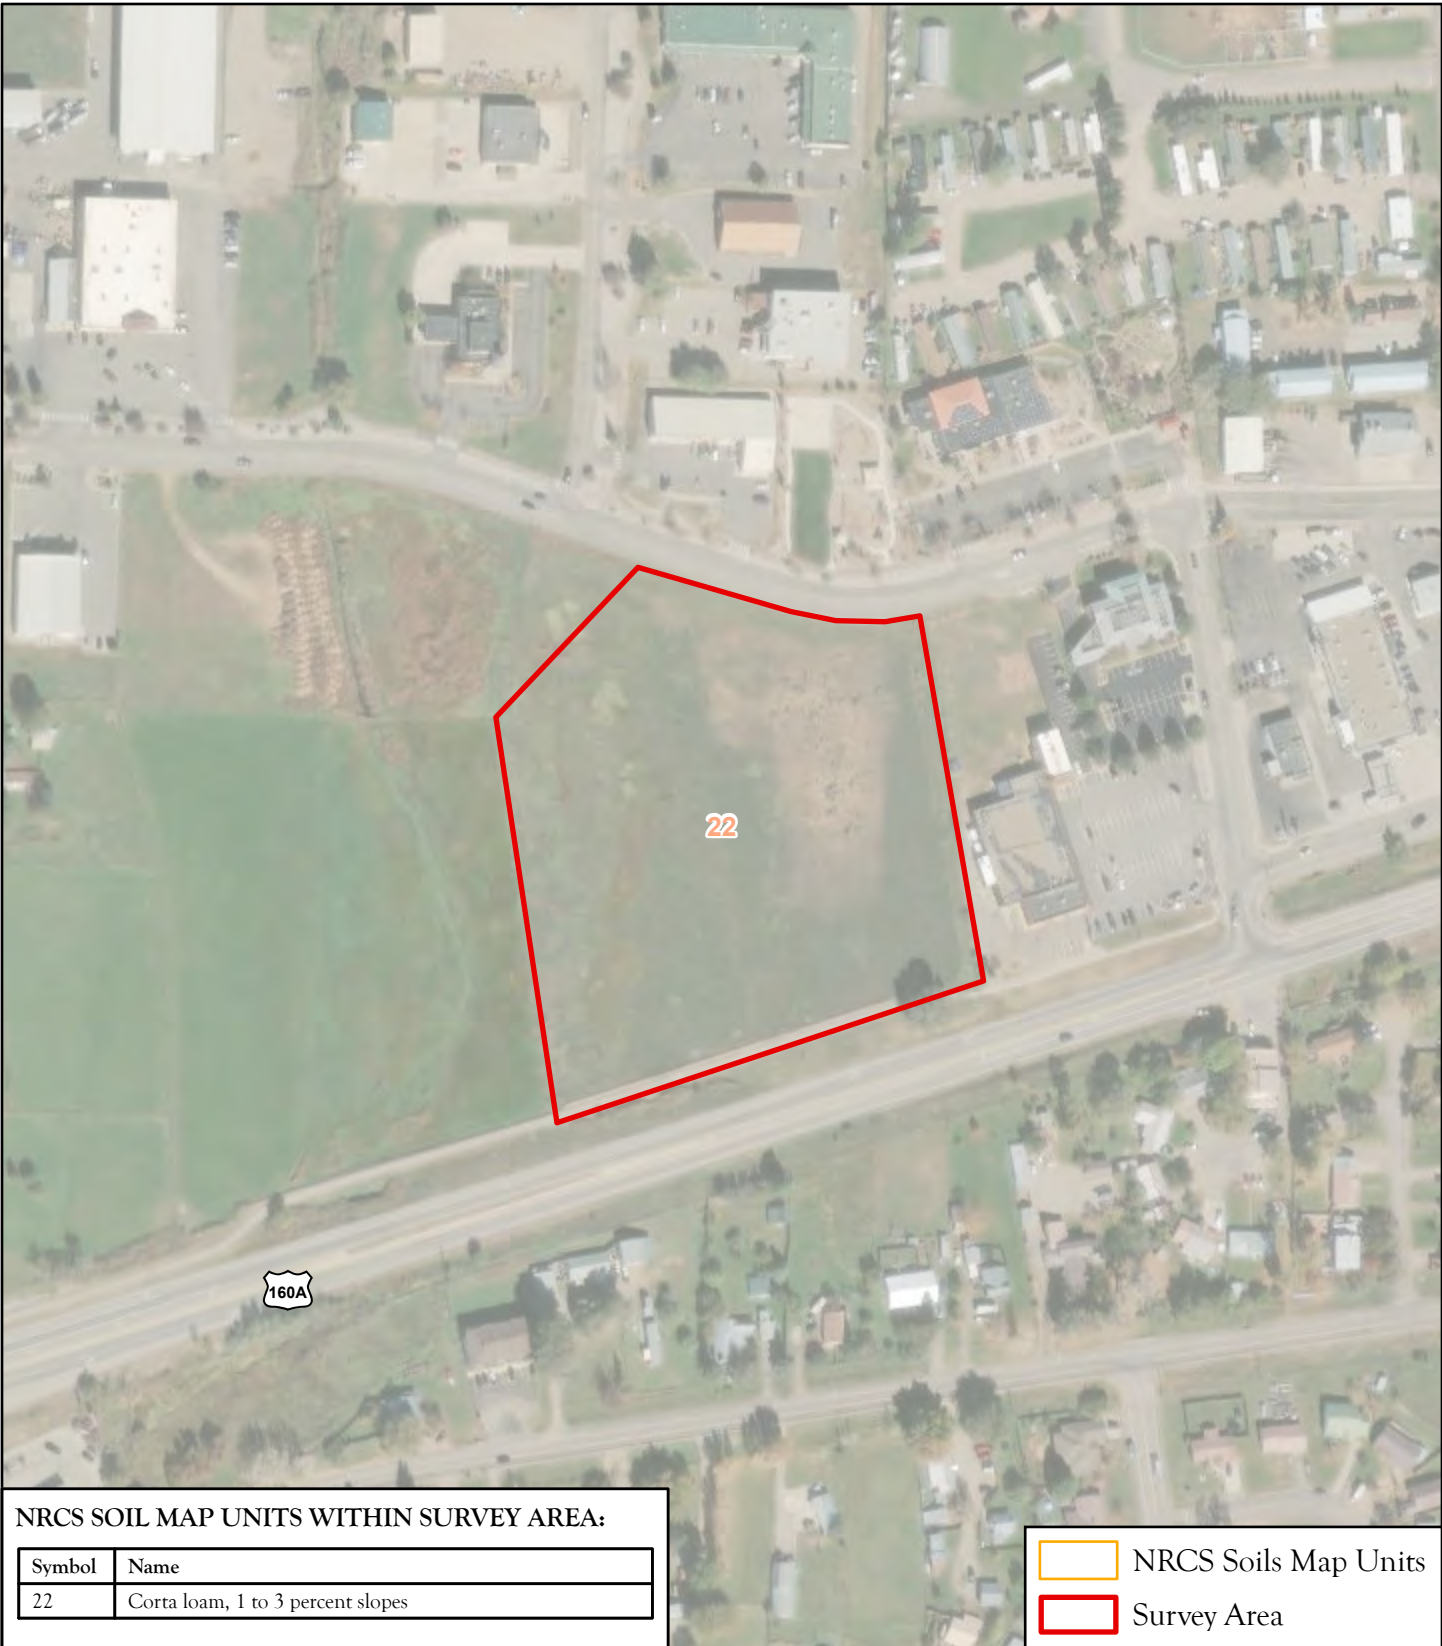
FIGURE

Soil data for the survey area was obtained from the USDA NRCS. A soil map is included as Figure 3. The survey area is fully within one map unit; a description of the unit is derived from the USDA NRCS Soil Reports and is provided below.

NRCS SOIL MAP UNITS WITHIN SURVEY AREA:

| Symbol | Name |
|---|---|
| 22 | Corta loam, 1 to 3 percent slopes |

SOILS MAP

Map Unit: 22—Corta loam, 1 to 3 percent slopes

The Corta component makes up 75 percent of the map unit. Slopes are 1 to 3 percent. This component is on old pediments, tops mesas, tops ridges. The parent material consists of fine-textured alluvium derived from shale and/or loess. Depth to a root restrictive layer is greater than 60 inches. The natural drainage class is well drained. Water movement in the most restrictive layer is moderately low. Available water to a depth of 60 inches (or restricted depth) is high. Shrink-swell potential is high. This soil is not flooded. It is not ponded. There is no zone of water saturation within a depth of 72 inches. Organic matter content in the surface horizon is about 2 percent. This component is in the F048AY925CO Ponderosa Pine Forest ecological site. Nonirrigated land capability classification is 3c. Irrigated land capability classification is 3e. This soil does not meet hydric criteria.

The Corta Loam soil unit is not listed on the State Soil Data Access (SDA) Hydric Soils List (NRCS, 2023).

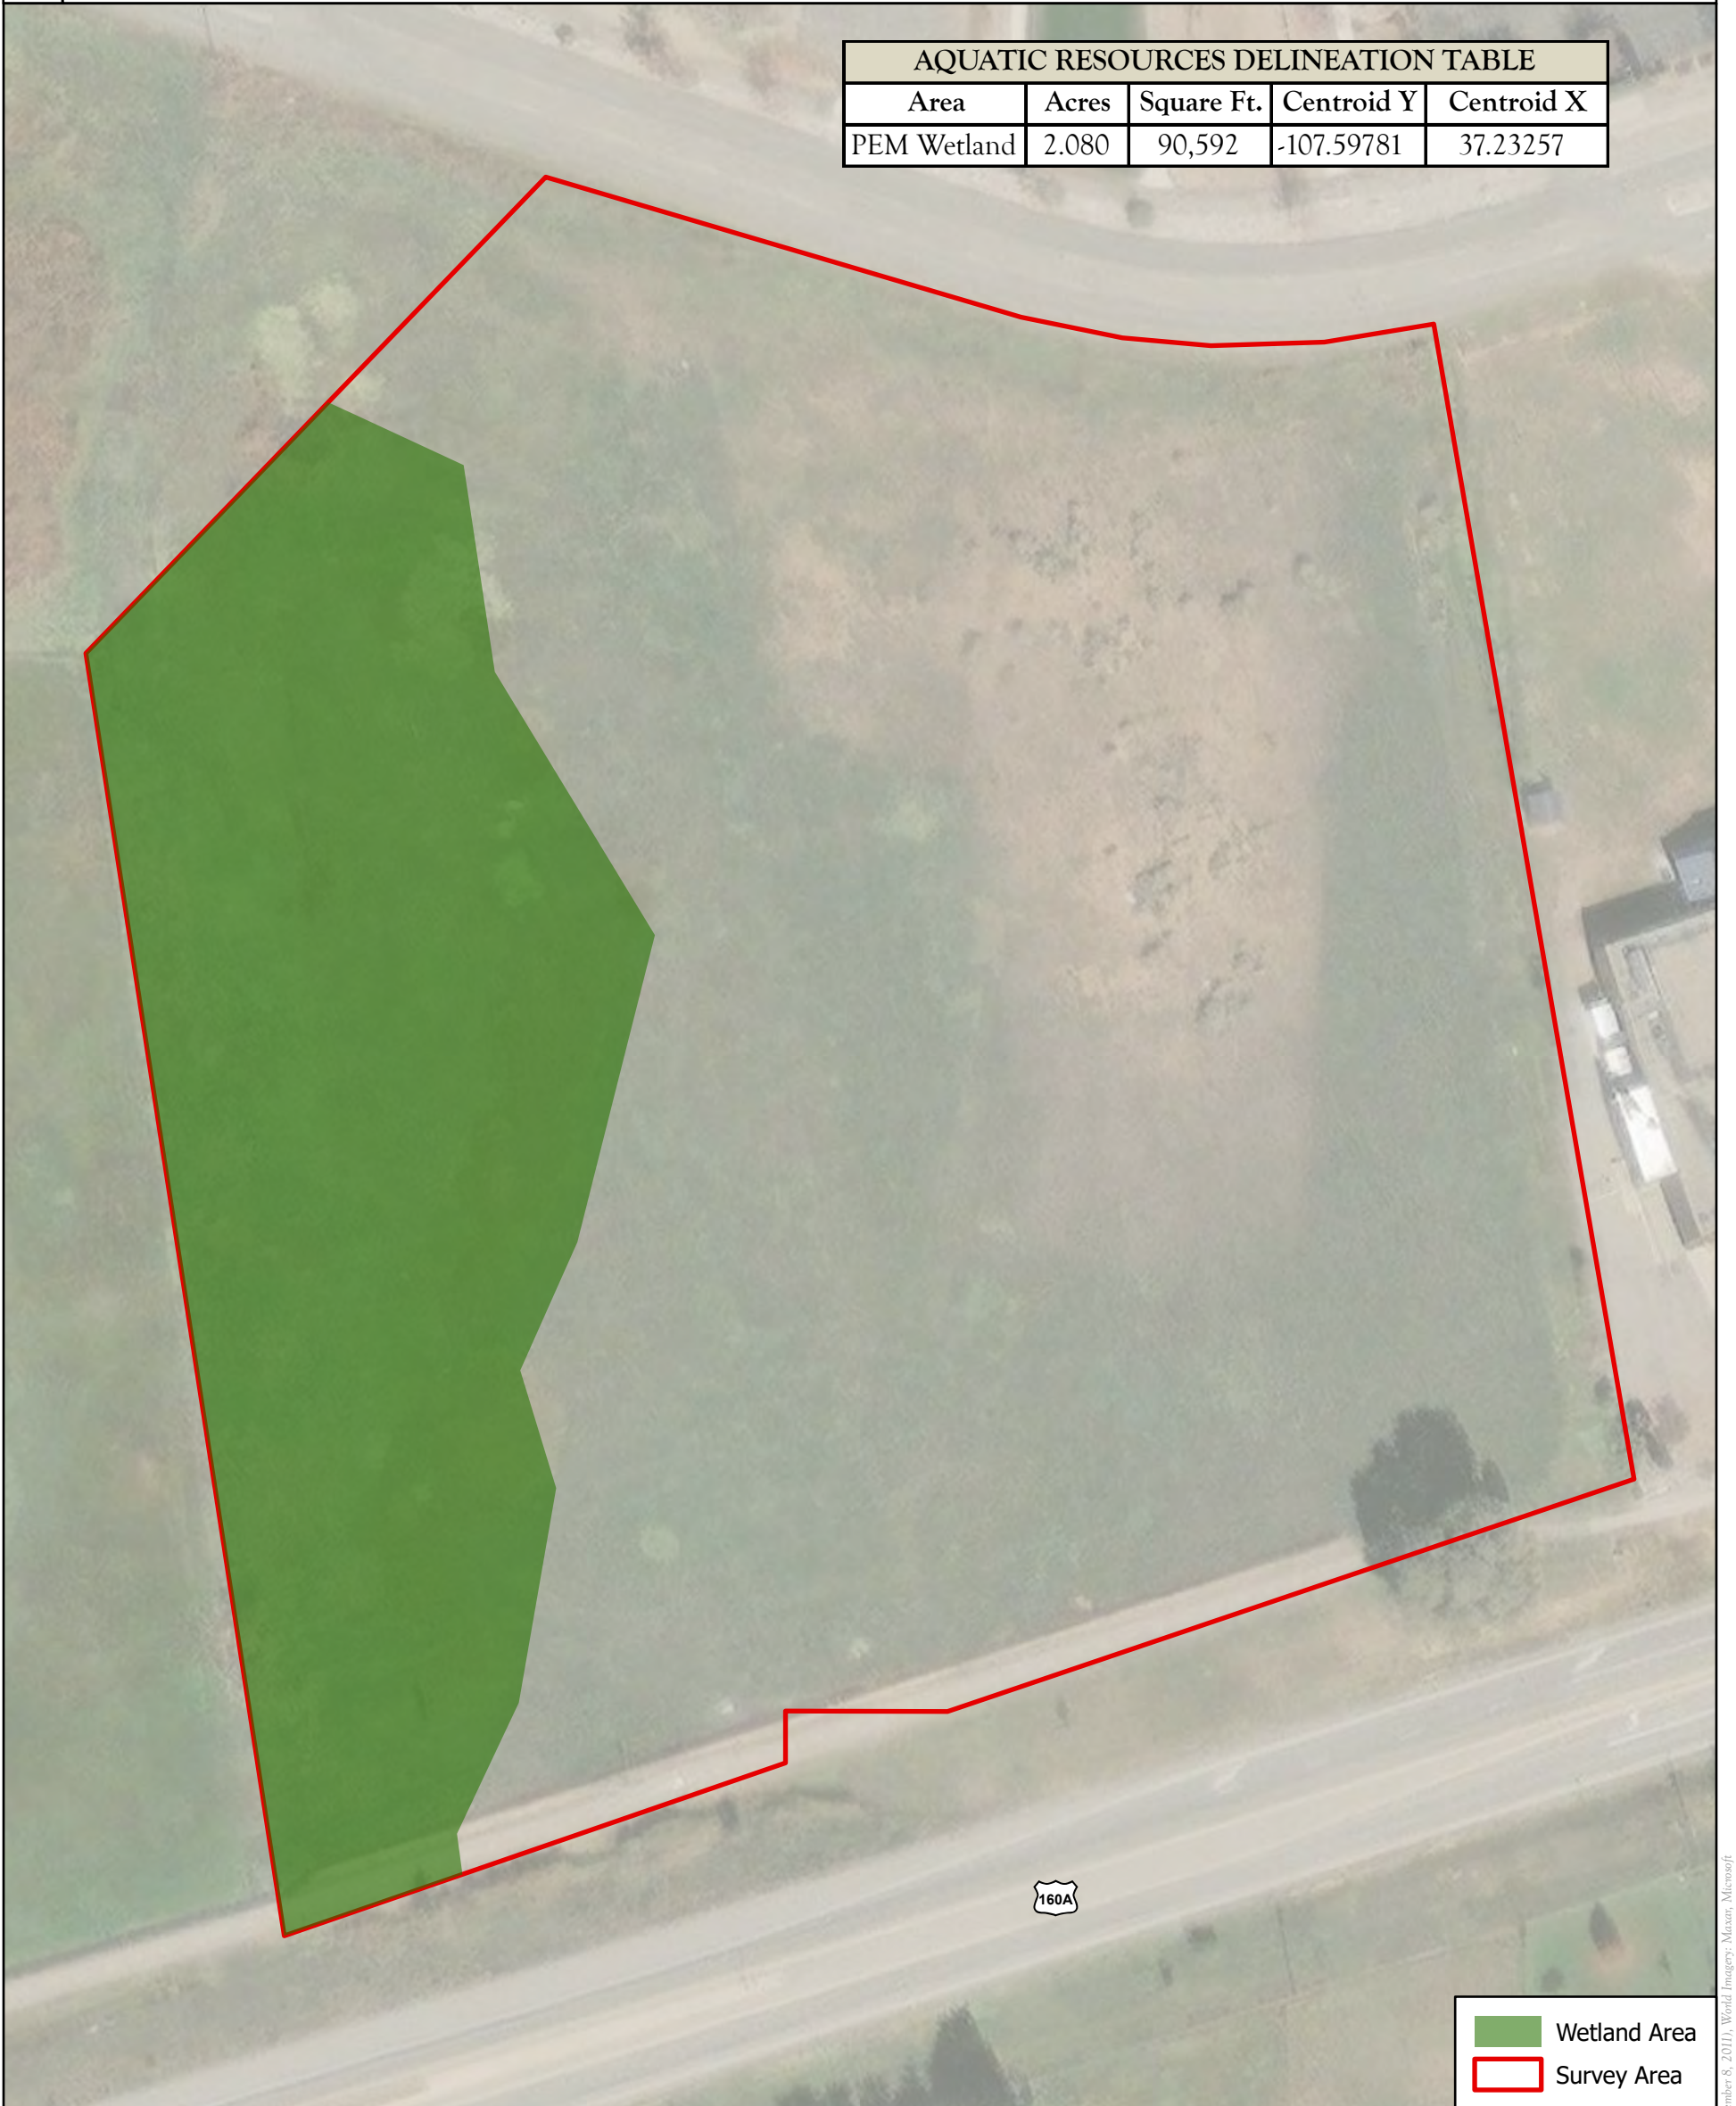
FIGURE
5

The freshwater pond shown on the National Wetlands Inventory map (Figure 4) in the northwestern corner of the property does not or no longer exists, as confirmed by field surveys. Aquatic resources on the property were conservatively mapped to ensure project design would fully avoid or minimize wetland impacts. Based on field surveys, the majority of the western third of the property consists of a palustrine emergent marsh (PEM) wetland complex. No other aquatic resources were mapped within the survey area. The approximate boundaries of aquatic resources in relation to the proposed project design are shown in Figure 5.

3. Wetland boundaries were defined based on presence of hydrophytic vegetation, hydric soils, and hydrologic indicators that under normal conditions would indicate wetland conditions. Where wetland conditions did not occur adjacent to surface water, the jurisdictional boundary was identified based on evidence of the OHWM.

| AQUATIC RESOURCES DELINEATION TABLE | | | | |
|---|---|---|---|---|
| PEM Wetland | 2.080 | 90,592 | -107.59781 | 37.23257 |

AQUATIC RESOURCES DELINEATION MAP

All wetland data was collected using Trimble GPS units and were located during SME's site visit and are subject to the limitations of SME GPS equipment (sub-meter accuracy) and USDA FSA NAIP Imagery which is used as the base for Figure 5.

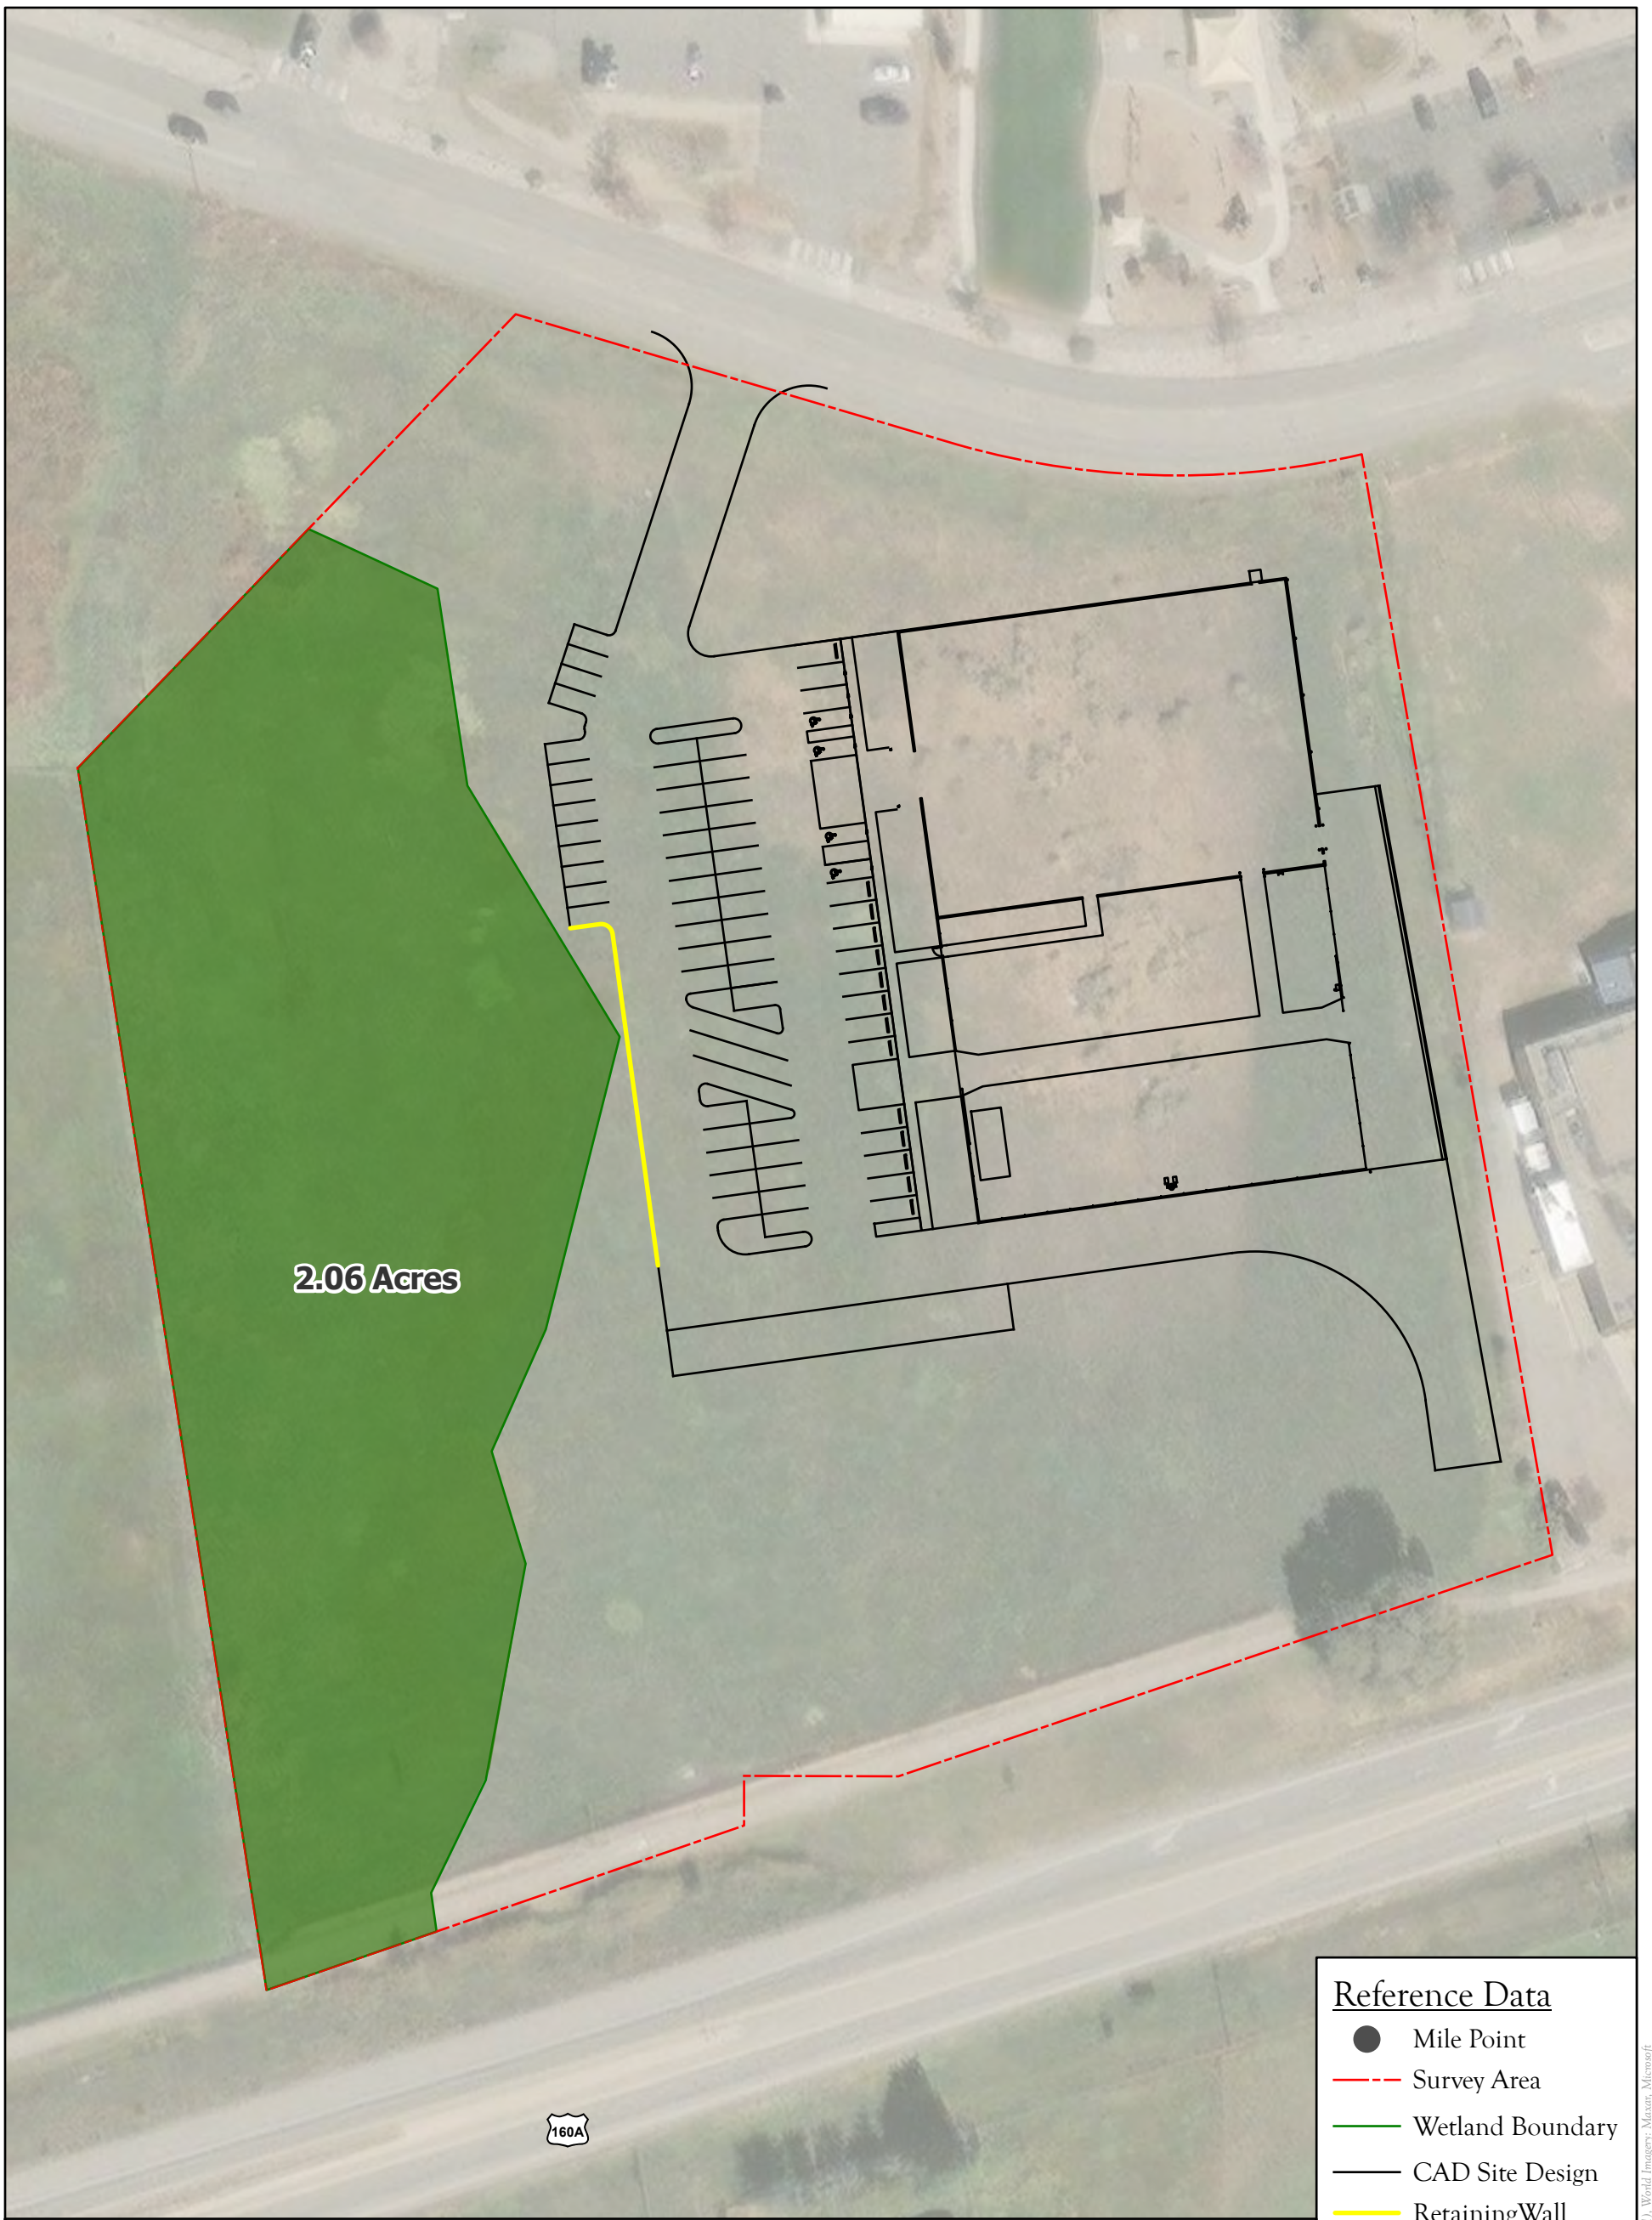
| AQUATIC RESOURCES BAYFIELD TRACTOR SUPPLY LA PLATA COUNTY, CO | FIGURE 6 |

The final Bayfield Tractor Supply site plan (Figure 6) avoids all wetland areas delineated by SME on the property. A previous iteration of the site plan would have incurred a small impact to the wetland complex due to the parking lot west of the proposed retail building overlapping with the eastern side of the wetland complex. In the end, the project design team decided to include a retaining wall in the final site plan along the edge of the parking lot to avoid any wetland impact in this location.

| SITE PLAN | |

Per your request, all wetlands on and within the Bayfield Tractor Supply Company property were mapped by SME in October of 2023. Based on SME’s field observations and the provided project design, it is SME’s opinion that that no impacts to aquatic resources will occur as a result of the development of the site plan depicted in Figure 6. Therefore, no 404 Permit will be necessary for the proposed project.

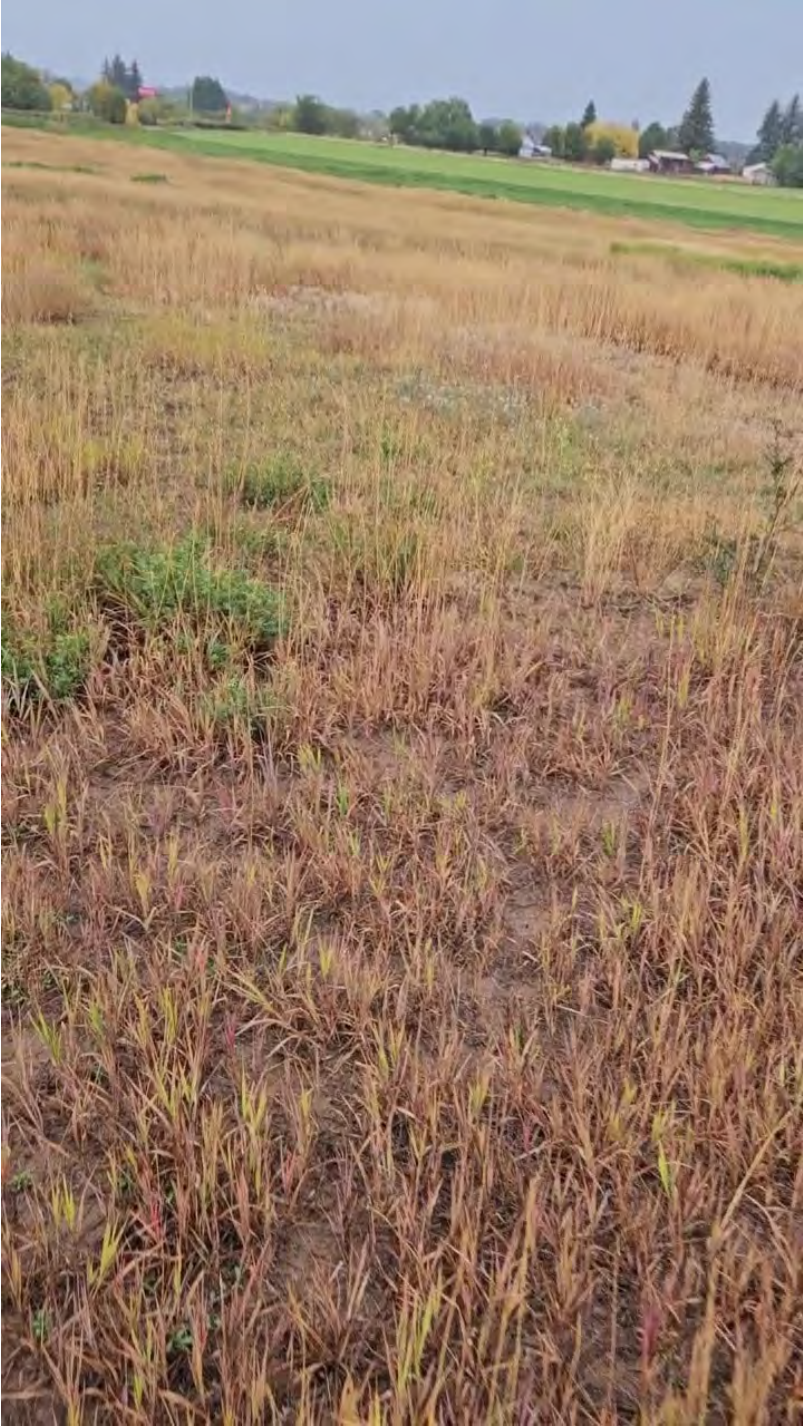
herb and graminoid species including smooth brome (*Bromus inermis*), alfalfa (*Medicago sativa*), and field pennycress (*Thlaspi arvense*). The delineation line to determine upland/wetland boundary was informed by the vegetation transitioning from dominance by smooth brome (upland area), to Northwest Territory sedge and reed canary grass (wetland area). Western wheat grass (*Pascopyrum smithii*) was present both in the wetland and upland areas in the transition zone between the upland and wetland areas mapped on the property. A full list of plant species observed during the site survey is provided as Attachment 2 and photographs of the vegetation zones observed on the site are included in Attachment 3.

Photograph 1. Upland area - dominated by smooth brome.

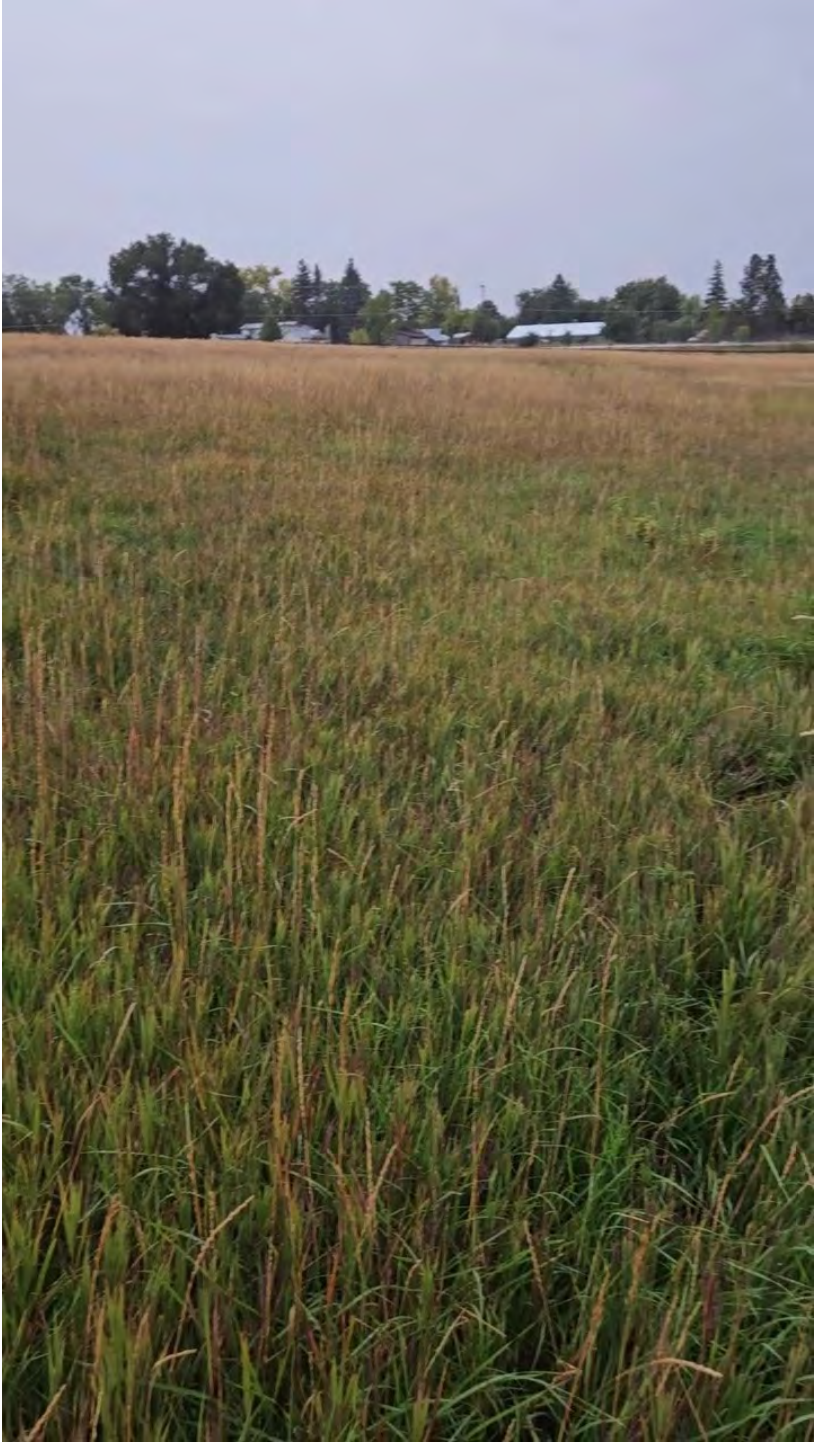
**Photograph 2. Transition area
– with western wheat grass
shown.**

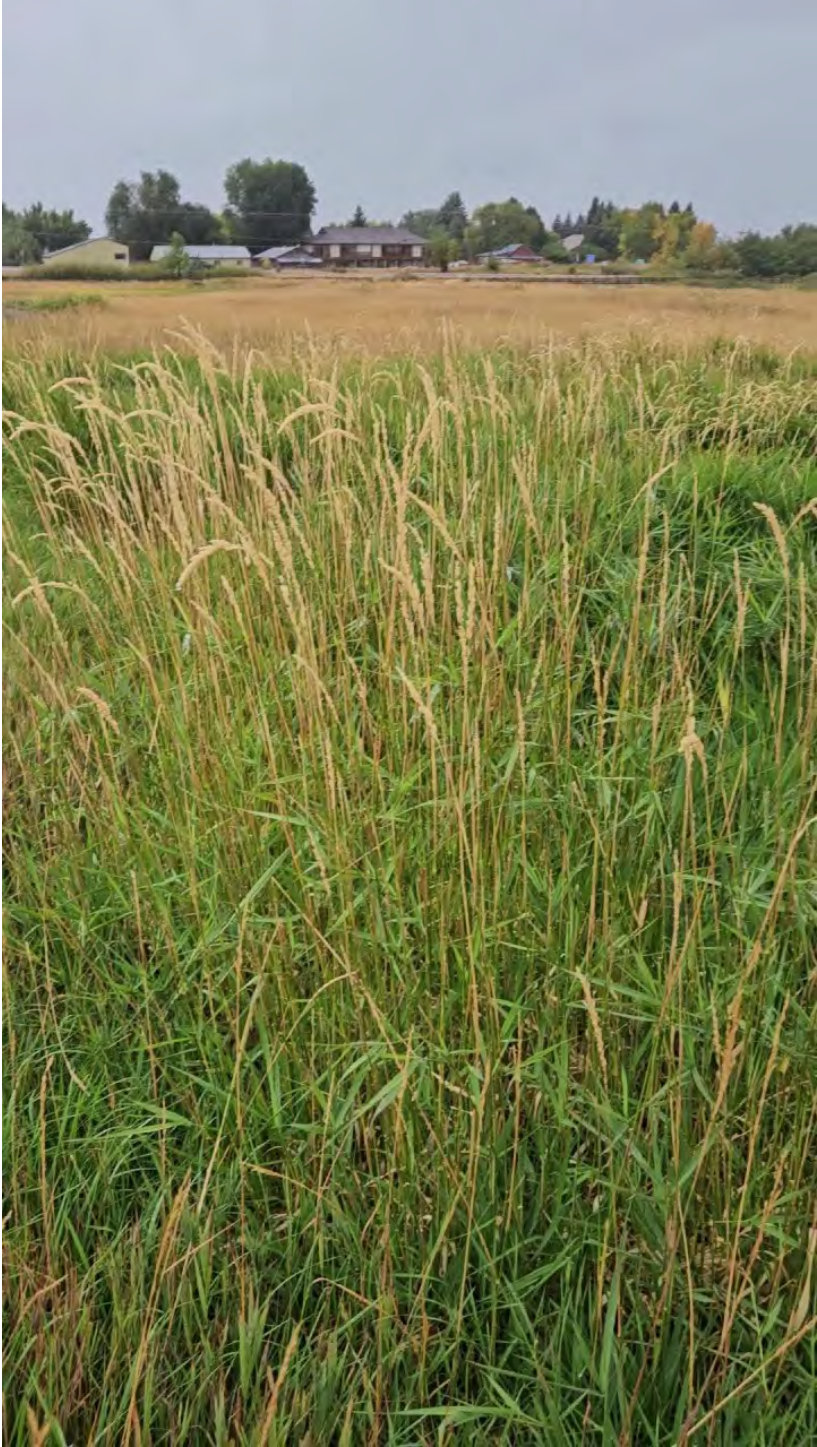
Wetlands in the survey area were dominated by reed canary grass (*Phalaris arundinacea*) and Northwest Territory sedge (*Carex utriculate*). Upland areas surveyed consisted of a variety of

There were also typical differences in both hydrologic and soil conditions observed on either side of the wetland/upland boundary. Soils within the wetland area were generally in the 10YR 3/2 Munsell color range with lighter redoximorphic features and were saturated at or near the surface. Soils within the upland area were generally in the 10YR 4/4 Munsell color range and were dry.

Photograph 3. Wetland area – dominated by reed canary grass with sedge in the background.
